**MINING AND RECLAMATION PLAN
AMENDMENT**

CRYSTAL CREEK AGGREGATES

DATE: March 26, 2007
REVISED: August 27, 2019; December 26, 2022

- A. Project Name: Mining and Reclamation Plan Amendment For Crystal Creek Aggregates.
- B. California Mine Identification Numbers: 91-45-0021 (Crystal Creek Aggregates)

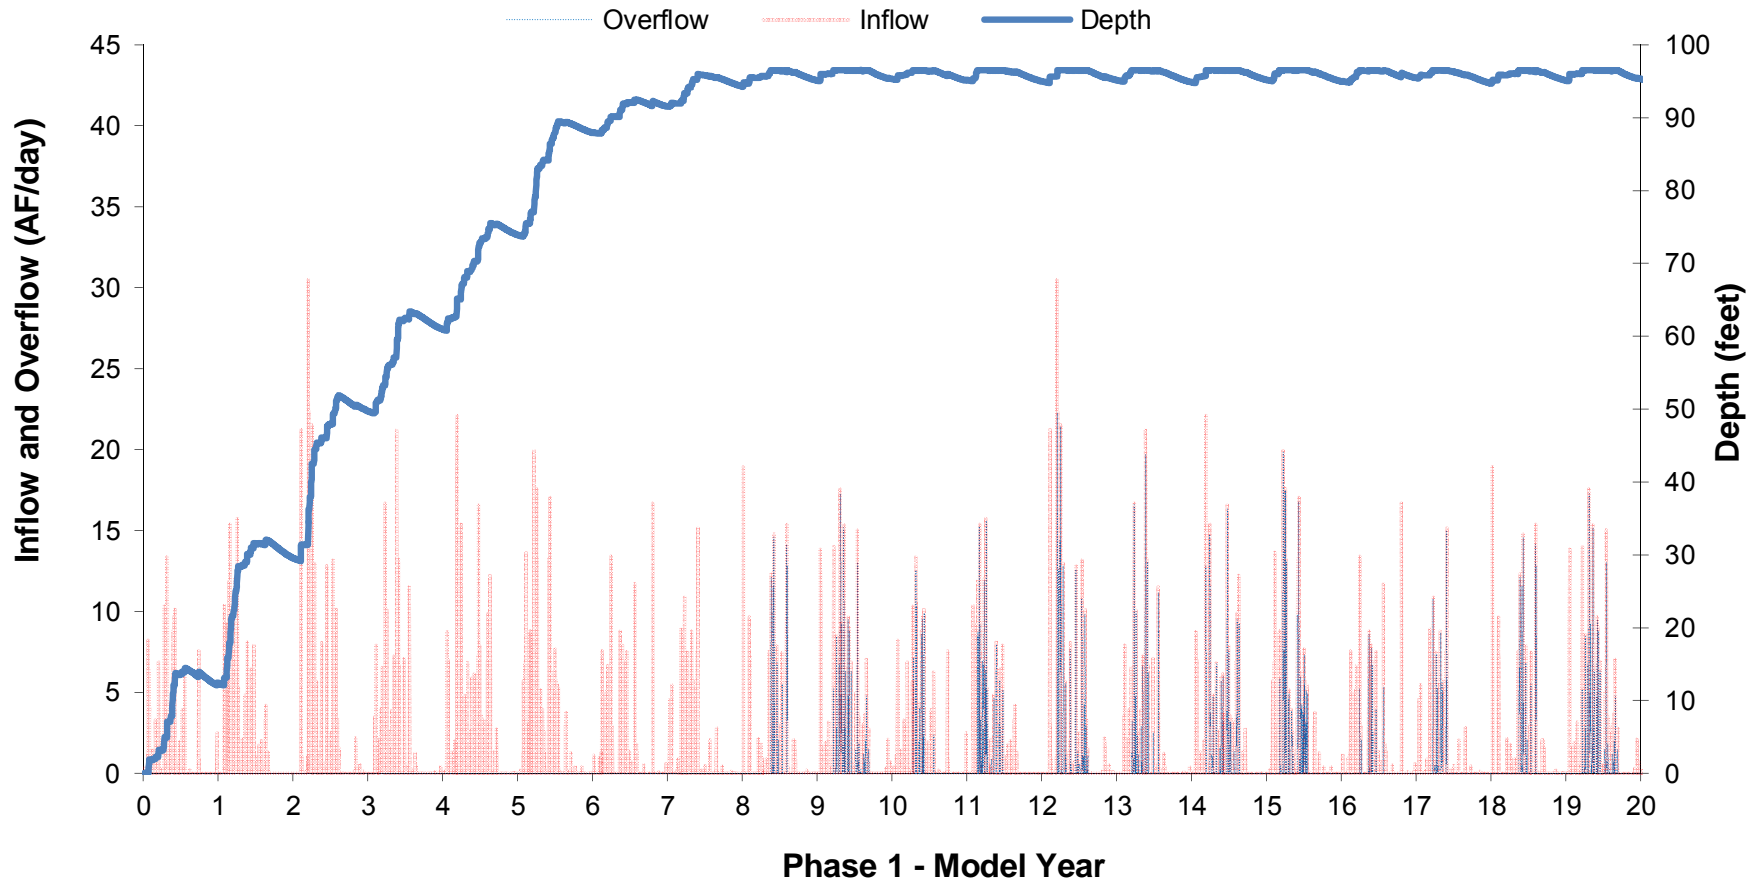
60.8" annual average precip., 49.2" annual evaporation, 0.0003 feet/day leakage

Crystal Creek Aggregate - New Lake - Phase 1 Drought Period (Based on 2007 - 2017 Precipitation)

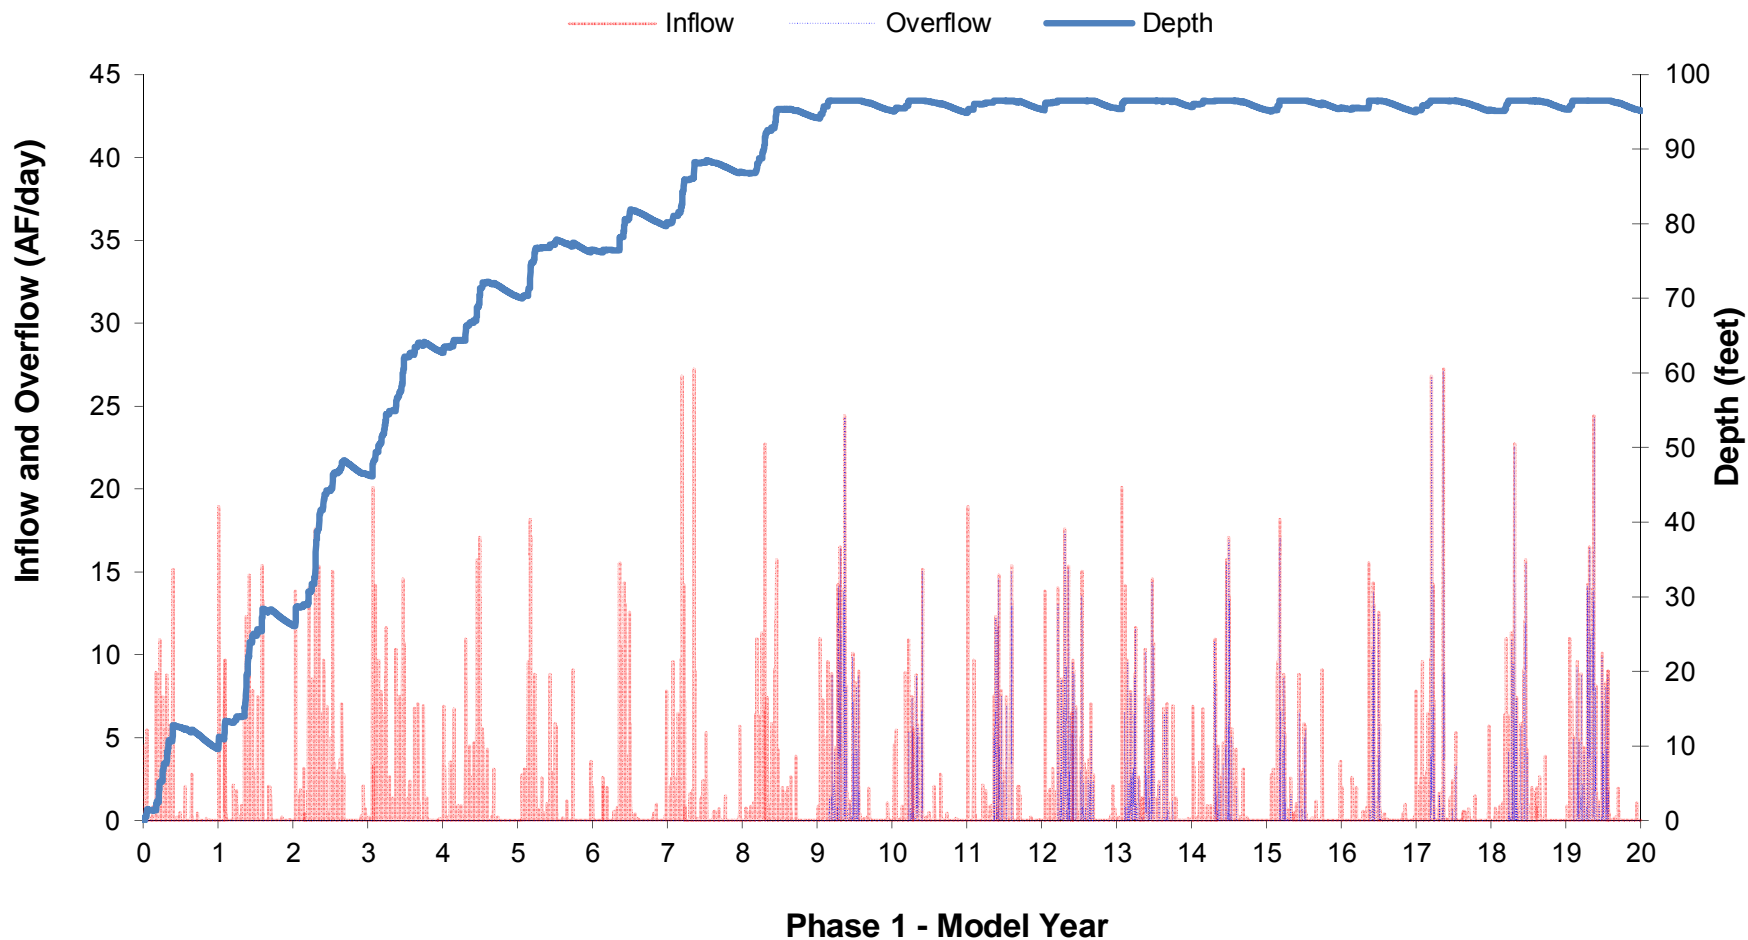
44.17" annual average dry period precipitation, 49.2" annual evaporation, 0.0003 feet/day leakage

Crystal Creek Aggregate - New Lake - Phase 1 Average Rainfall Period (Based on 2001 - 2011)

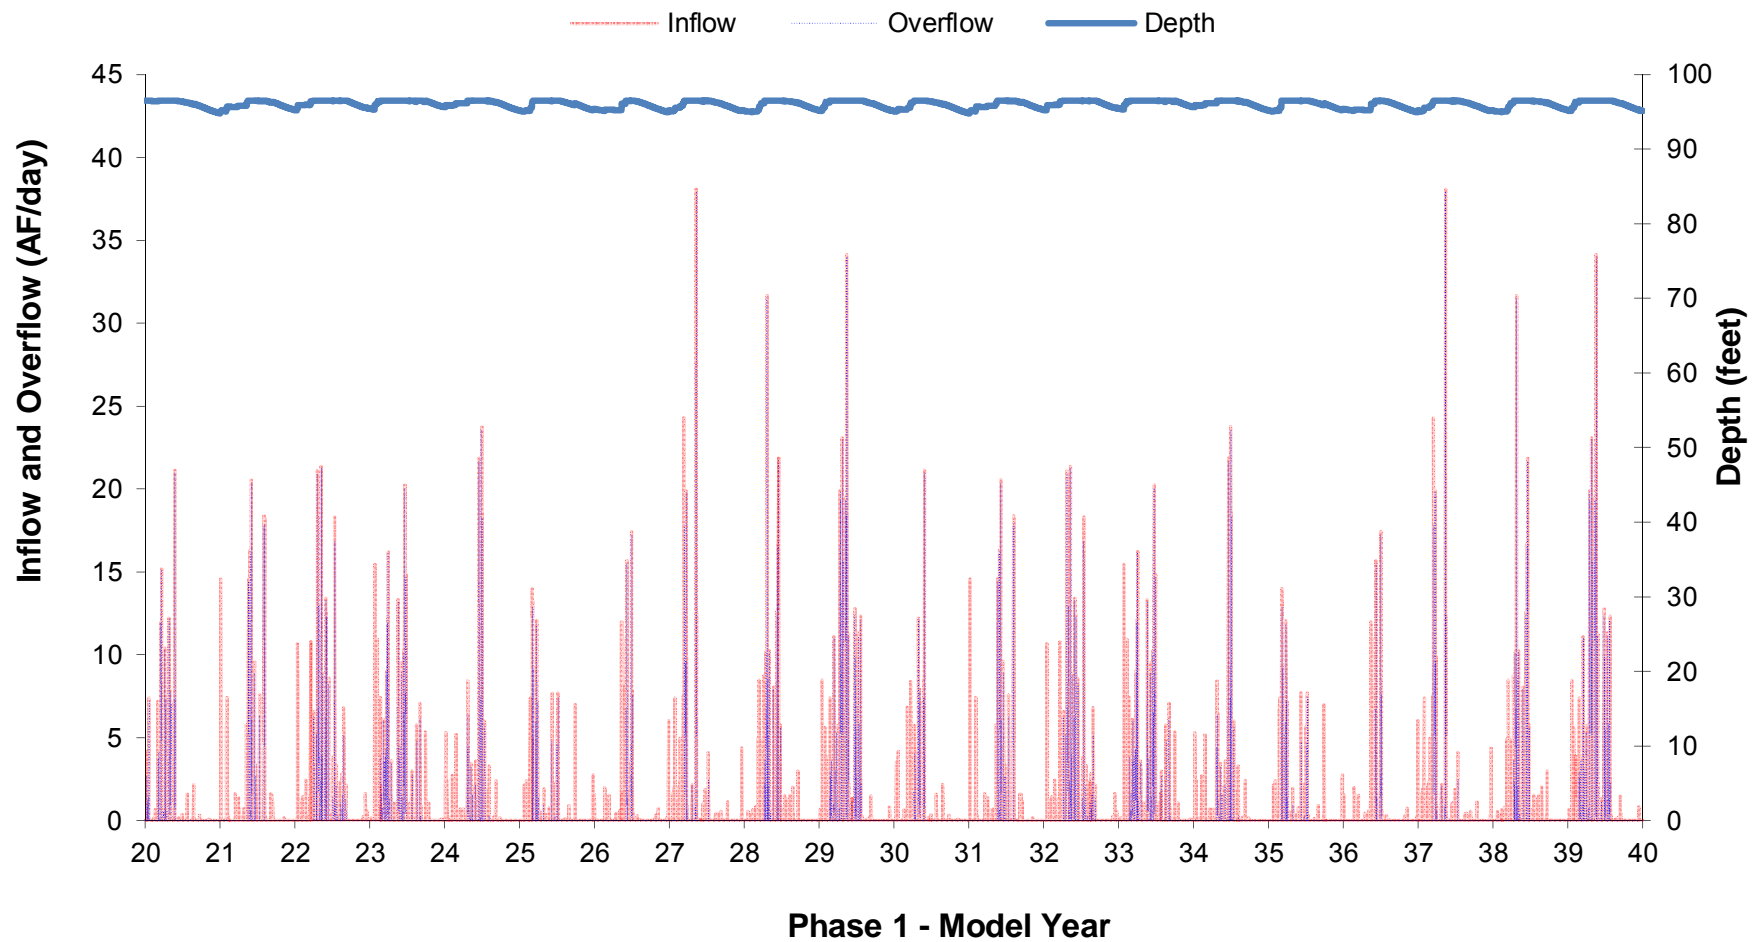
44.17" annual average dry period precipitation, 49.2" annual evaporation, 0.0003 feet/day leakage

Crystal Creek Aggregate - New Lake - Phase 1 Average Rainfall Period (Based on 2001 - 2011)

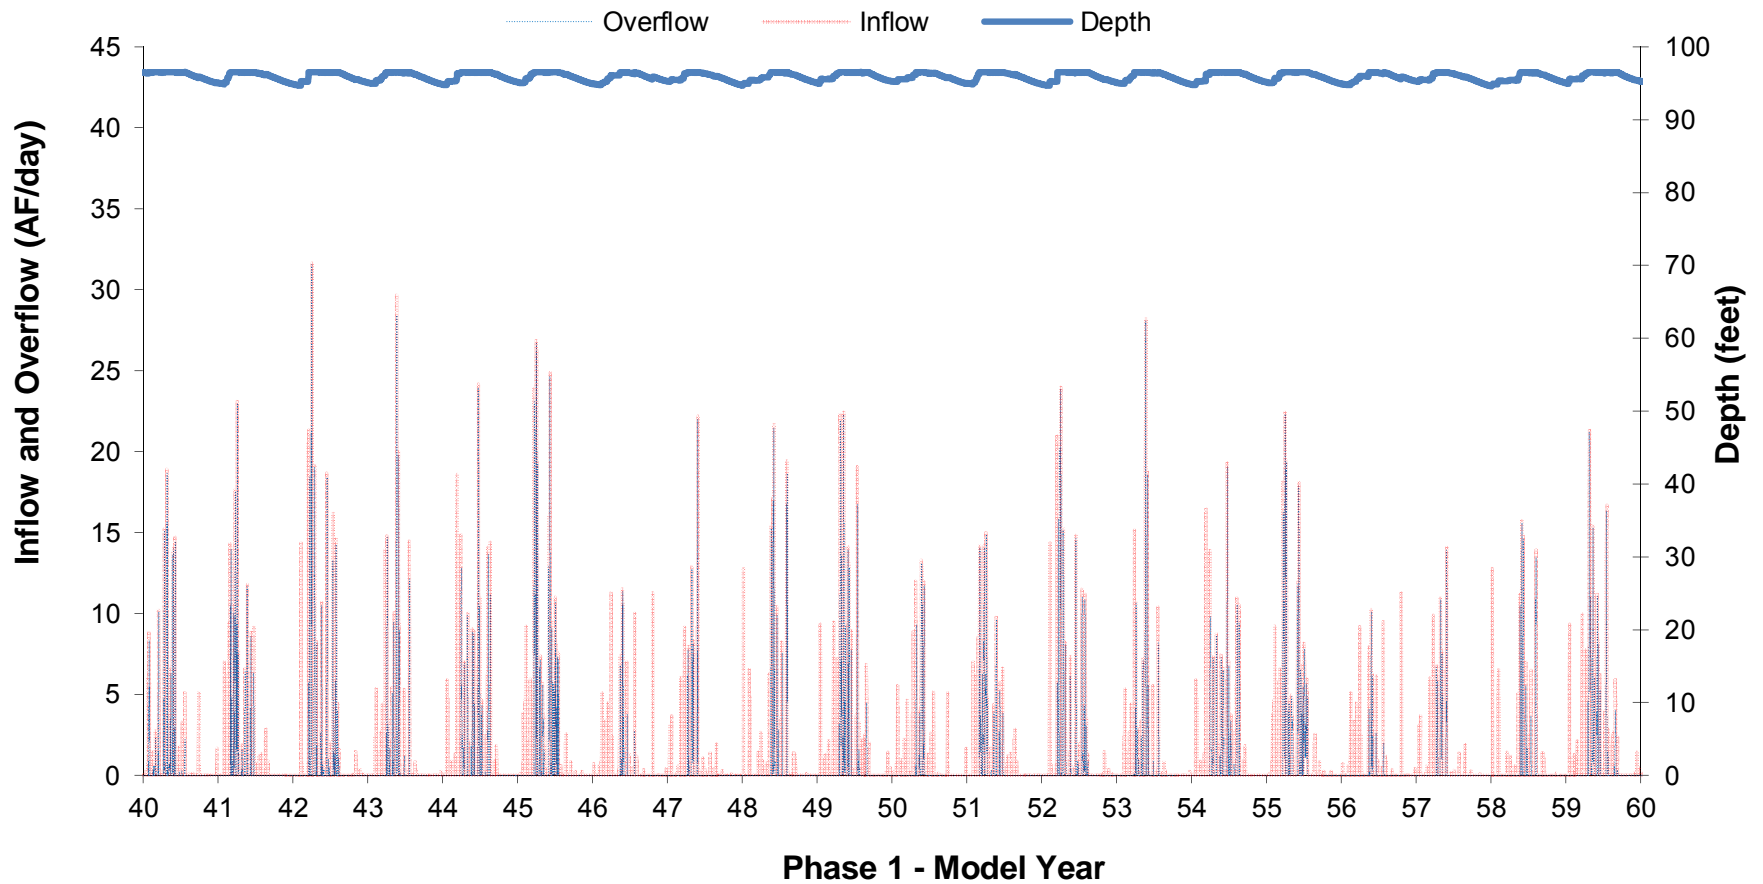
60.8" annual average precip., 49.2" annual evaporation, 0.0003 feet/day leakage

Crystal Creek Aggregate - New Lake - Phase 1 Drought Period (Based on 2007 - 2017 Precipitation)

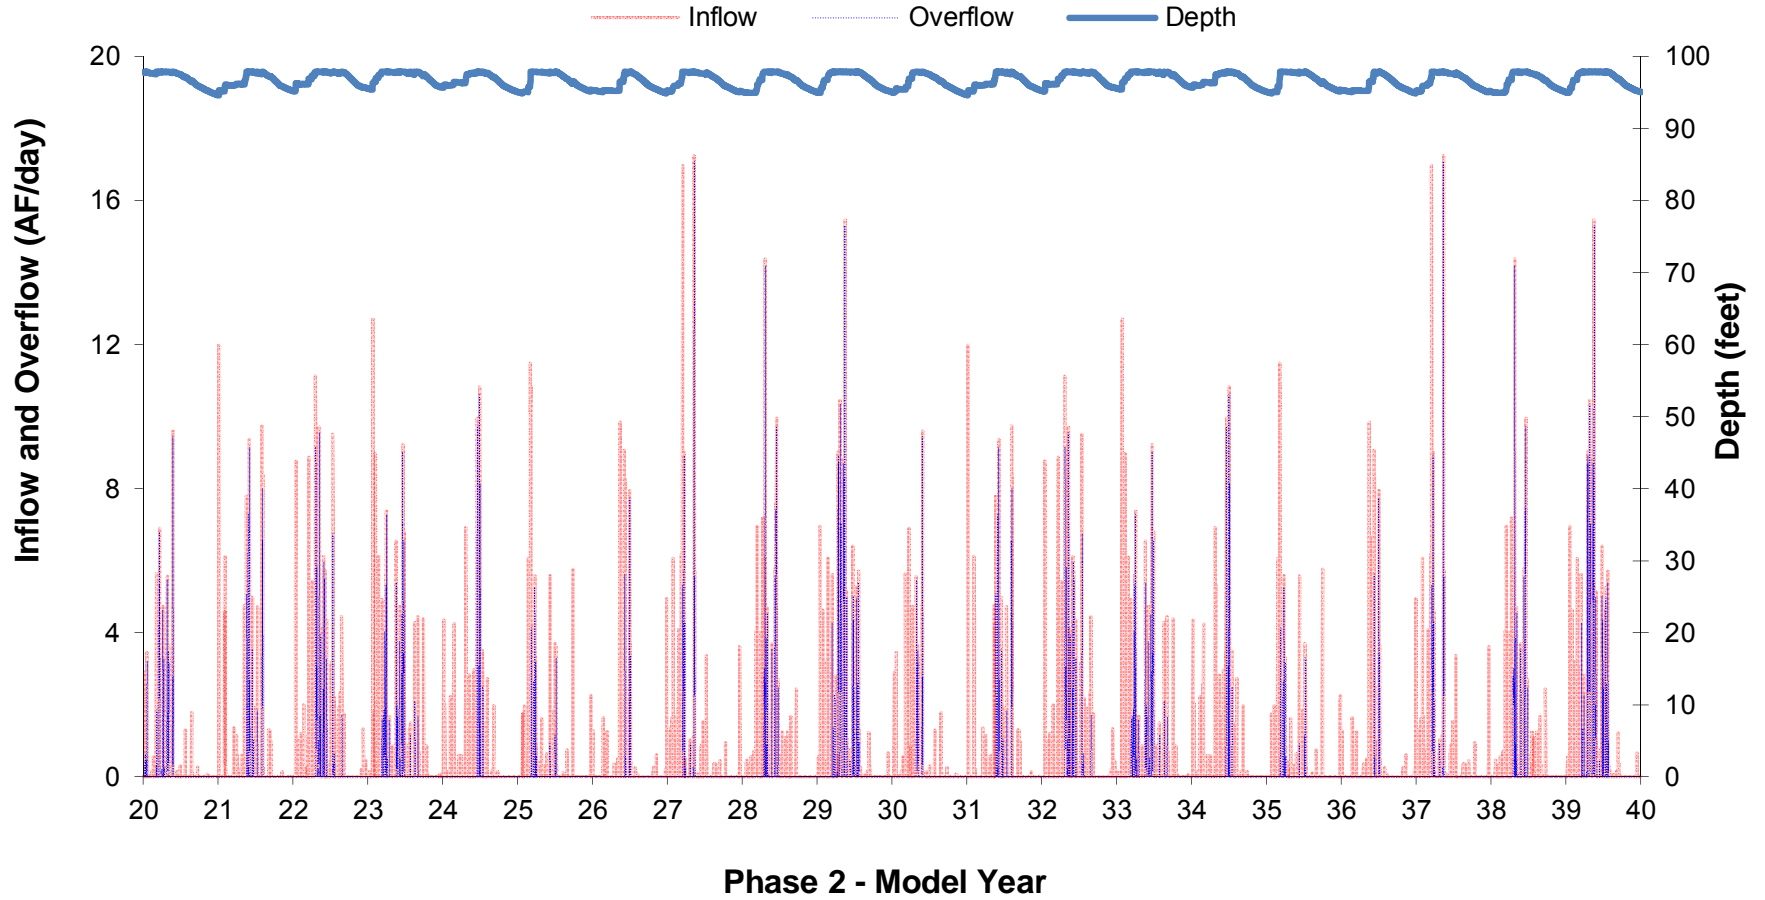
44.17" annual average dry period precipitation, 49.2" annual evaporation, 0.0003 feet/day leakage

Crystal Creek Aggregate - New Lake - Phase 2 Average Rainfall Period (Based on 2001 - 2011)

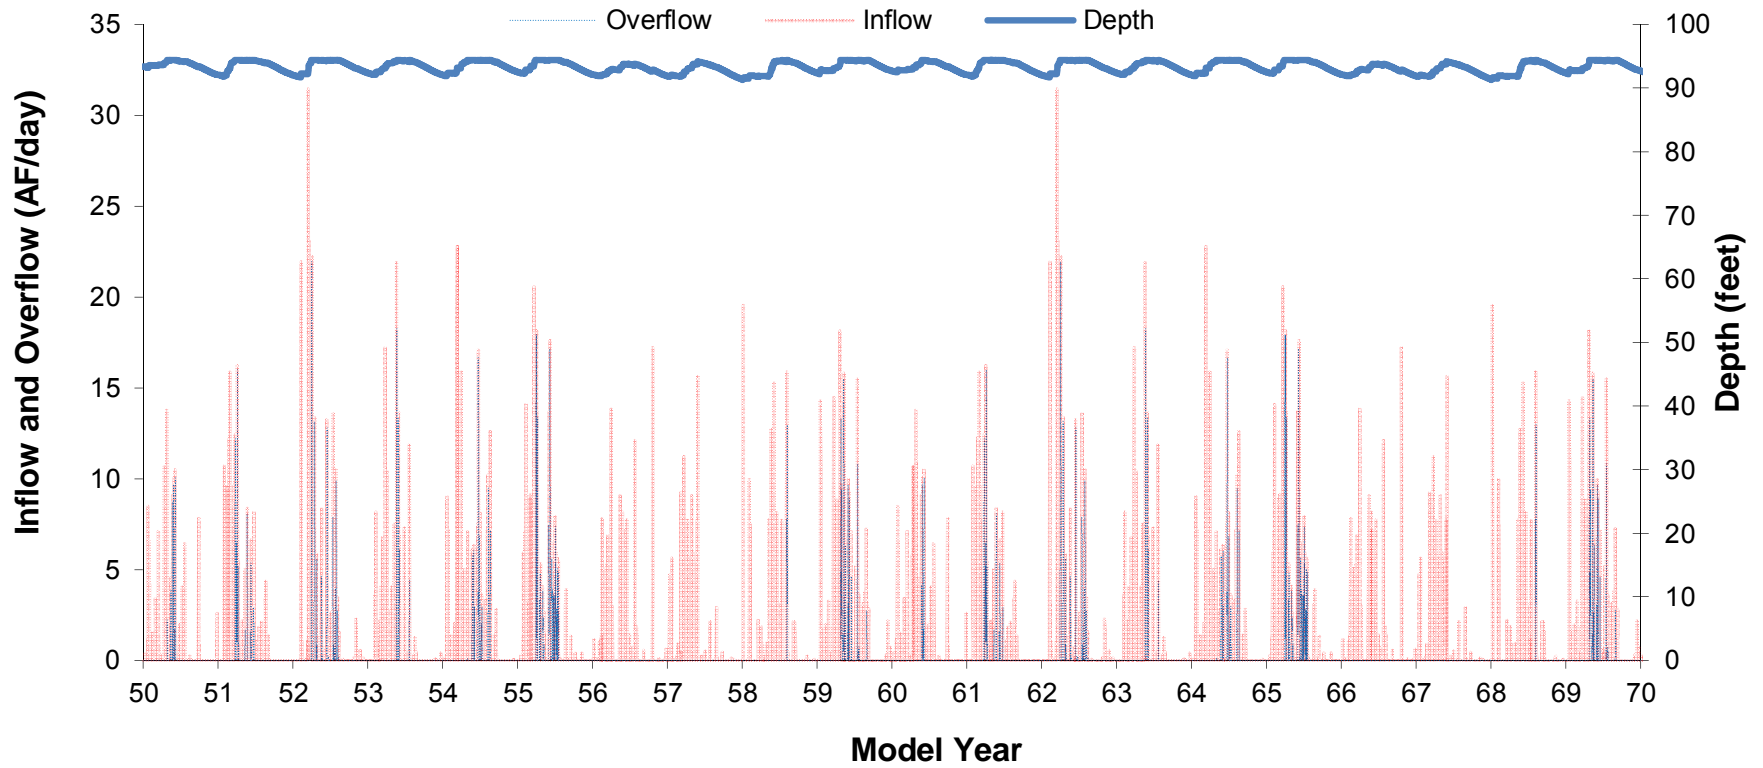
Crystal Creek Aggregate - New Lake - Entire Lake Drought Period (Based on 2007 - 2017 Precipitation)

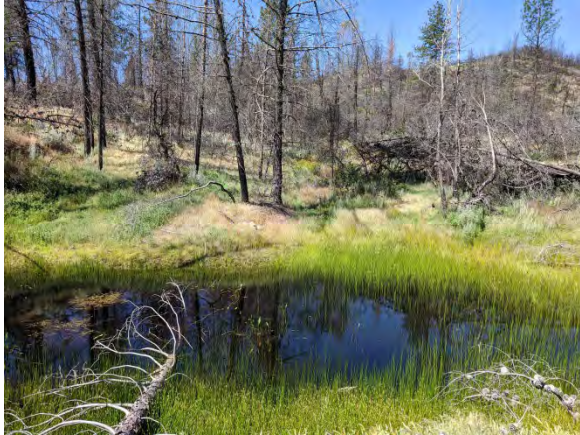
Pond where western pond turtle was observed

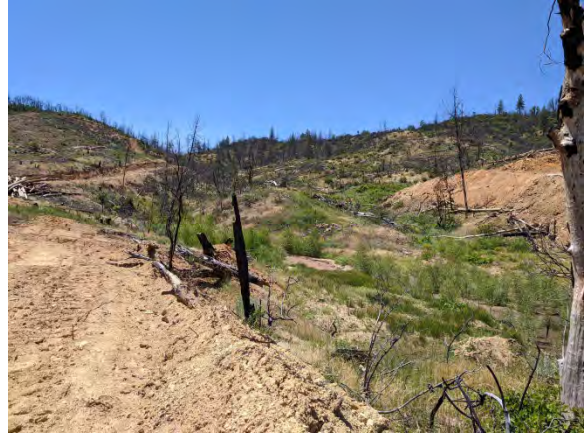
Overview of intermittent drainage
